TECHNOLOGY OVERVIEW

The current case involves a patient with a deltoid ligament tear causing ankle pain and medial ankle instability.

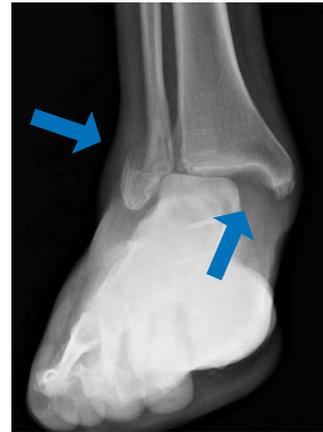
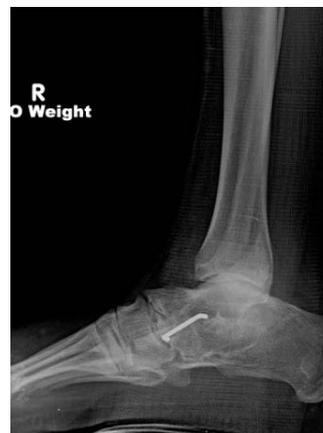
Figures 1&2: Radiographs of the right foot/ankle showing fractured fibula and wide mortise.

A 52-year-old healthy male presented after sustaining a slip and fall off of a ladder. Clinically he presented with pain and swelling along both the medial and lateral sides of his ankle. Radiographs revealed an obvious fibular fracture with a subsequent deltoid tear, allowing the mortise to widen (Figures 1 & 2)

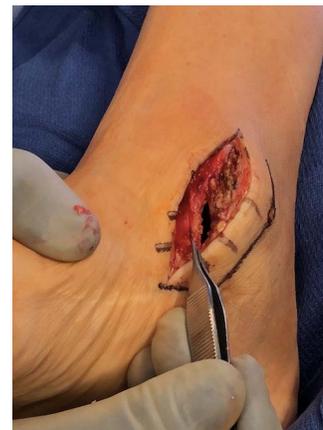
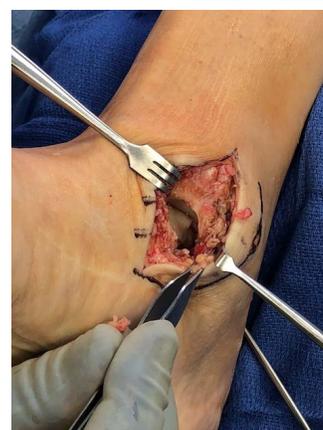
Figures 3&4: Intraoperative images showing torn deltoid ligament.

Upon incision, the ankle was grossly unstable with both the fractured fibula and the ruptured deltoid ligament confirmed. (Figure 3,4) While the fracture could be managed with open reduction and internal fixation, the large ligamentous defect and degenerated deltoid tissue made primary ligament repair impossible. Reconstruction & augmentation was necessary and a 0.7 x 8cm Artelon FlexBand was determined to be strong enough to help sustain the forces across the ruptured ligament. (Figure 3 & 4)

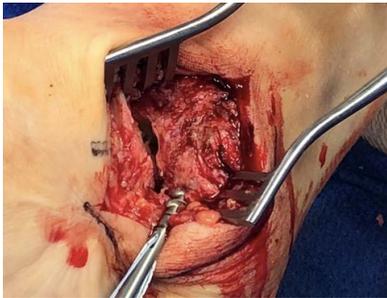
Figure 5: Inserting anchor into the deltoid origin/ medial malleolus.

After the fibula was reduced and stabilized with a plate and screws, an incision was made along the medial ankle in order to inspect the medial joint and revealed a torn deltoid ligament. Therefore, the medial malleolus deltoid insertion site was debrided and an anchor was used to secure a 0.7 x 8cm FlexBand matrix to the distal tibial (Figures 5-7). Next, the unattached end of the FlexBand was pulled into 10-20% tension and secured directly to the talus deltoid insertion point with a second anchor (Figures 8-9). Excess FlexBand was trimmed away and the remaining native deltoid ligament was wrapped around the implanted matrix (Figure 10). Final manipulation felt stable and x-rays confirmed that the ankle had been reduced (Figure 11).

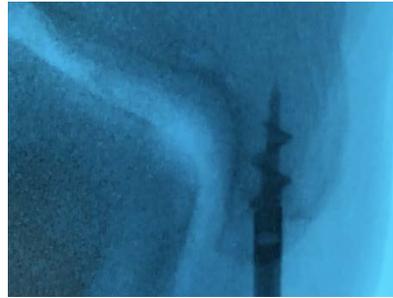
Figure 6: Anchor placement confirmed with fluoroscopy.

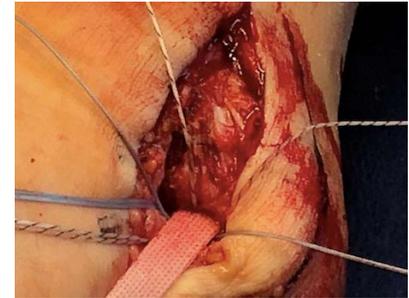
Figure 7: Securing FlexBand matrix to the medial malleolus/deltoid origin.

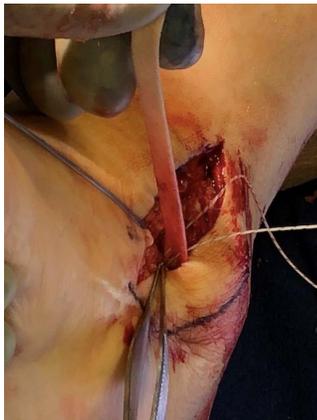
Figure 8: Anchor in the deltoid insertion (talus). Tensioned and secured the FlexBand.

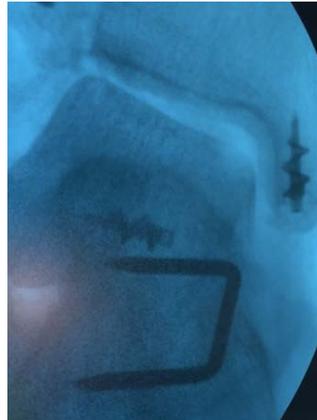
Figure 9: Anchor placement confirmed with fluoroscopy.

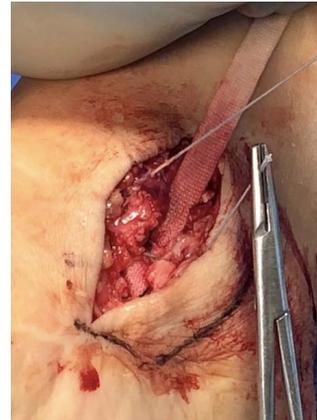
Figure 10: Deltoid remnants wrapped around the FlexBand matrix as part of repair.

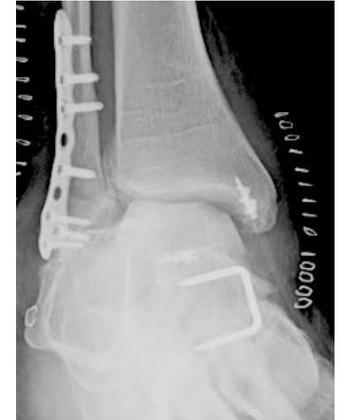
Figure 11: Post-op radiographs showing reduced mortise.
